# EIGHTH QUARTERLY PROGRESS REPORT (COVERING JANUARY THROUGH MARCH 1978)

## ACCELERATED / ABBREVIATED TEST METHODS, STUDY 4 OF TASK 3 (ENCAPSULATION) OF THE LOW-COST SILICON SOLAR ARRAY PROJECT

JPL CONTRACT NO. 954458

**Rockwell International**

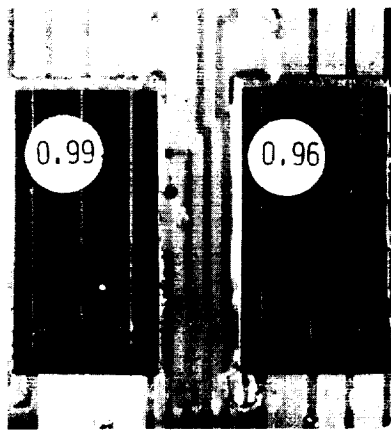
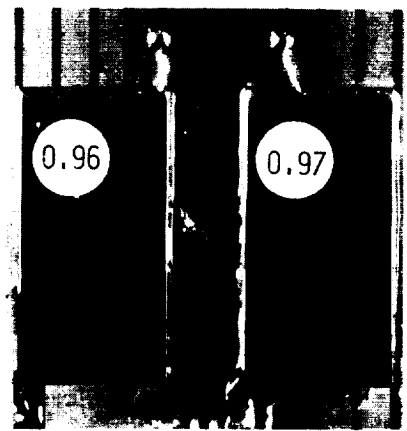
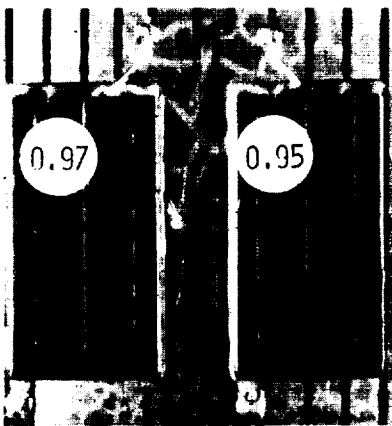
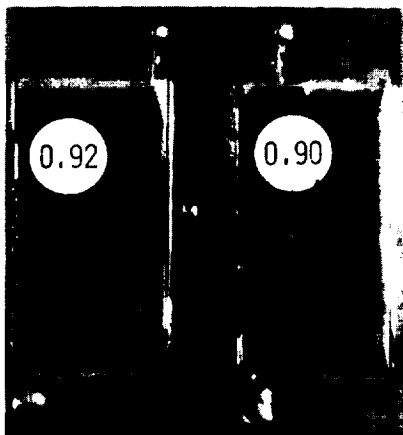
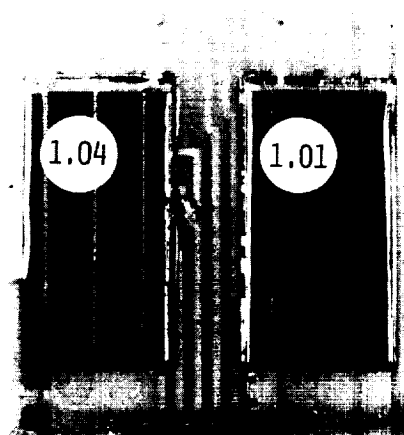
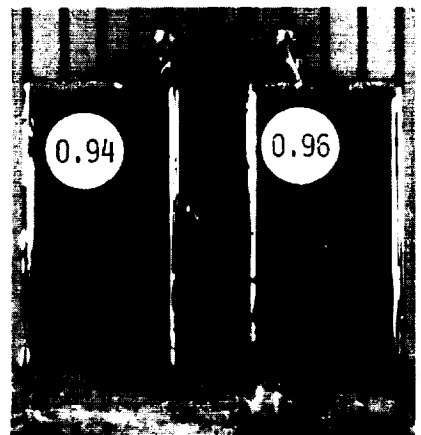
FIGURE 13. ENCAPSULANT SYSTEM #7 (NITROCELLULOSE LACQUER ENCAPSULANT, EPOXY SUBSTRATE) AFTER 61 DAYS ACCELERATED EXPOSURE

NOTE: FRACTION OF ORIGINAL POWER IS SHOWN FOR EACH CELL.

Figure 13 shows nitrocellulose lacquer after exposure to all 8 accelerated conditions. It illustrates the advantages of multicondition exposure in clarifying the relative effect of UV light, temperature, and moisture. For convenience, the nine photographs will be referred to as #1, 2, and 3 from left to right across the top, #4, 5, and 6 across the middle, and #7, 8, and 9 across the bottom. The following conclusions are drawn by comparing these photographs. Figures 15, 16, and 26 also are referred to.

- (1) The most pronounced visible degradation (blistering) is caused by:
  - (a) More UV - #6 worse than #9  
#5 worse than #8
  - (b) Higher temperatures - #6 worse than #4
  - (c) Increased humidity - #6 worse than #5  
#4 worse than #3  
#7 worse than #2  
#9 worse than #8
- (2) Blistering is proportional to light intensity. Compare #9 with #7, showing a relatively fine "orange peel" texture, and with #6.
- (3) Photograph #3 represents NOCT at noon in a dry, desert climate. Photograph #4 represents NOCT at noon in a moist climate such as Miami. These results illustrate the dramatic differences in encapsulant performance possible for dry vs. wet sites.

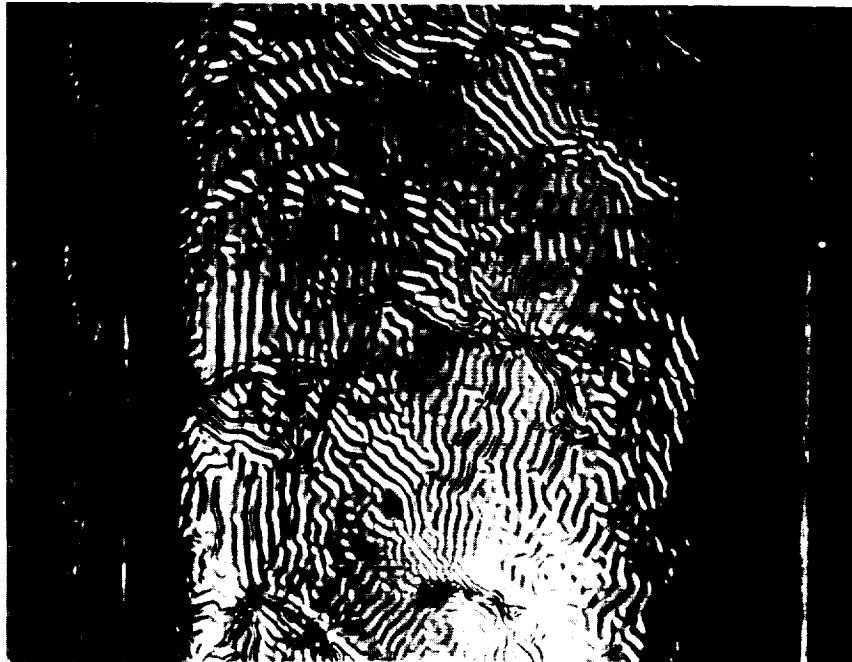
Figure 14. Encapsulant System #7 (Nitrocellulose Lacquer, Epoxy Substrate) After 61 Days Accelerated Exposure.  
Conditions: 0.66 UV, 64°C, 100% R.H., Magnified 10X

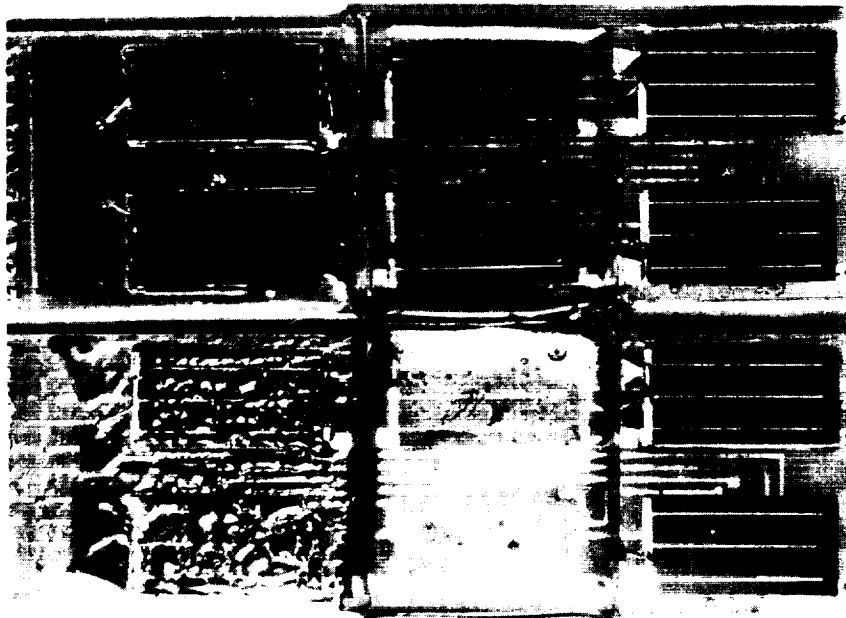
Figure 15. Encapsulant Systems #7-9 (Epoxy Substrate) After 61 Days Accelerated Exposure.  
Conditions: 1.00 Rel. UV, 72°C.  
Above: 0% R.H. Below: 100% R.H.  
Encapsulant Covers, left to right: nitrocellulose lacquer, 2B74, 2B74 + glass.

- (4) Incidentally, referring to Figure 15, the effect of humidity in causing loss of gloss of the polyurethane encapsulant is clearly shown.
- (5) The nitrocellulose lacquer was degraded by moisture alone, with no previous UV exposure, at 100° C (Figures 16 (right column) and 26). However, previous UV exposure without moisture caused greater degradation in subsequent steam exposure. Therefore, weather factors can have a sequential effect.

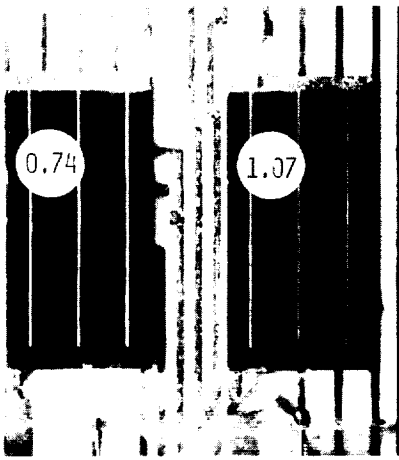
FIGURE 16. ENCAPSULANT SYSTEMS AFTER 61 DAYS ACCELERATED EXPOSURE FOLLOWED BY 12 DAYS STEAM EXPOSURE.

NOTE: FRACTION OF ORIGINAL POWER IS SHOWN FOR EACH CELL.

These UTS's were next exposed to steam at 100° C for 12 days. Considerable additional degradation occurred. Results are summarized in Tables VI - XI and Figure 16.

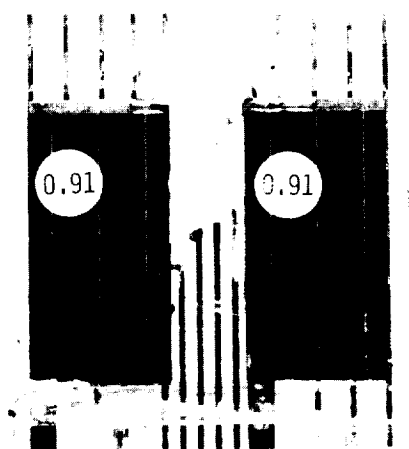
FIGURE 26. ENCAPSULANT SYSTEMS AFTER 61 DAYS ACCELERATED EXPOSURE  
FOLLOWED BY 31 DAYS STEAM EXPOSURE.
